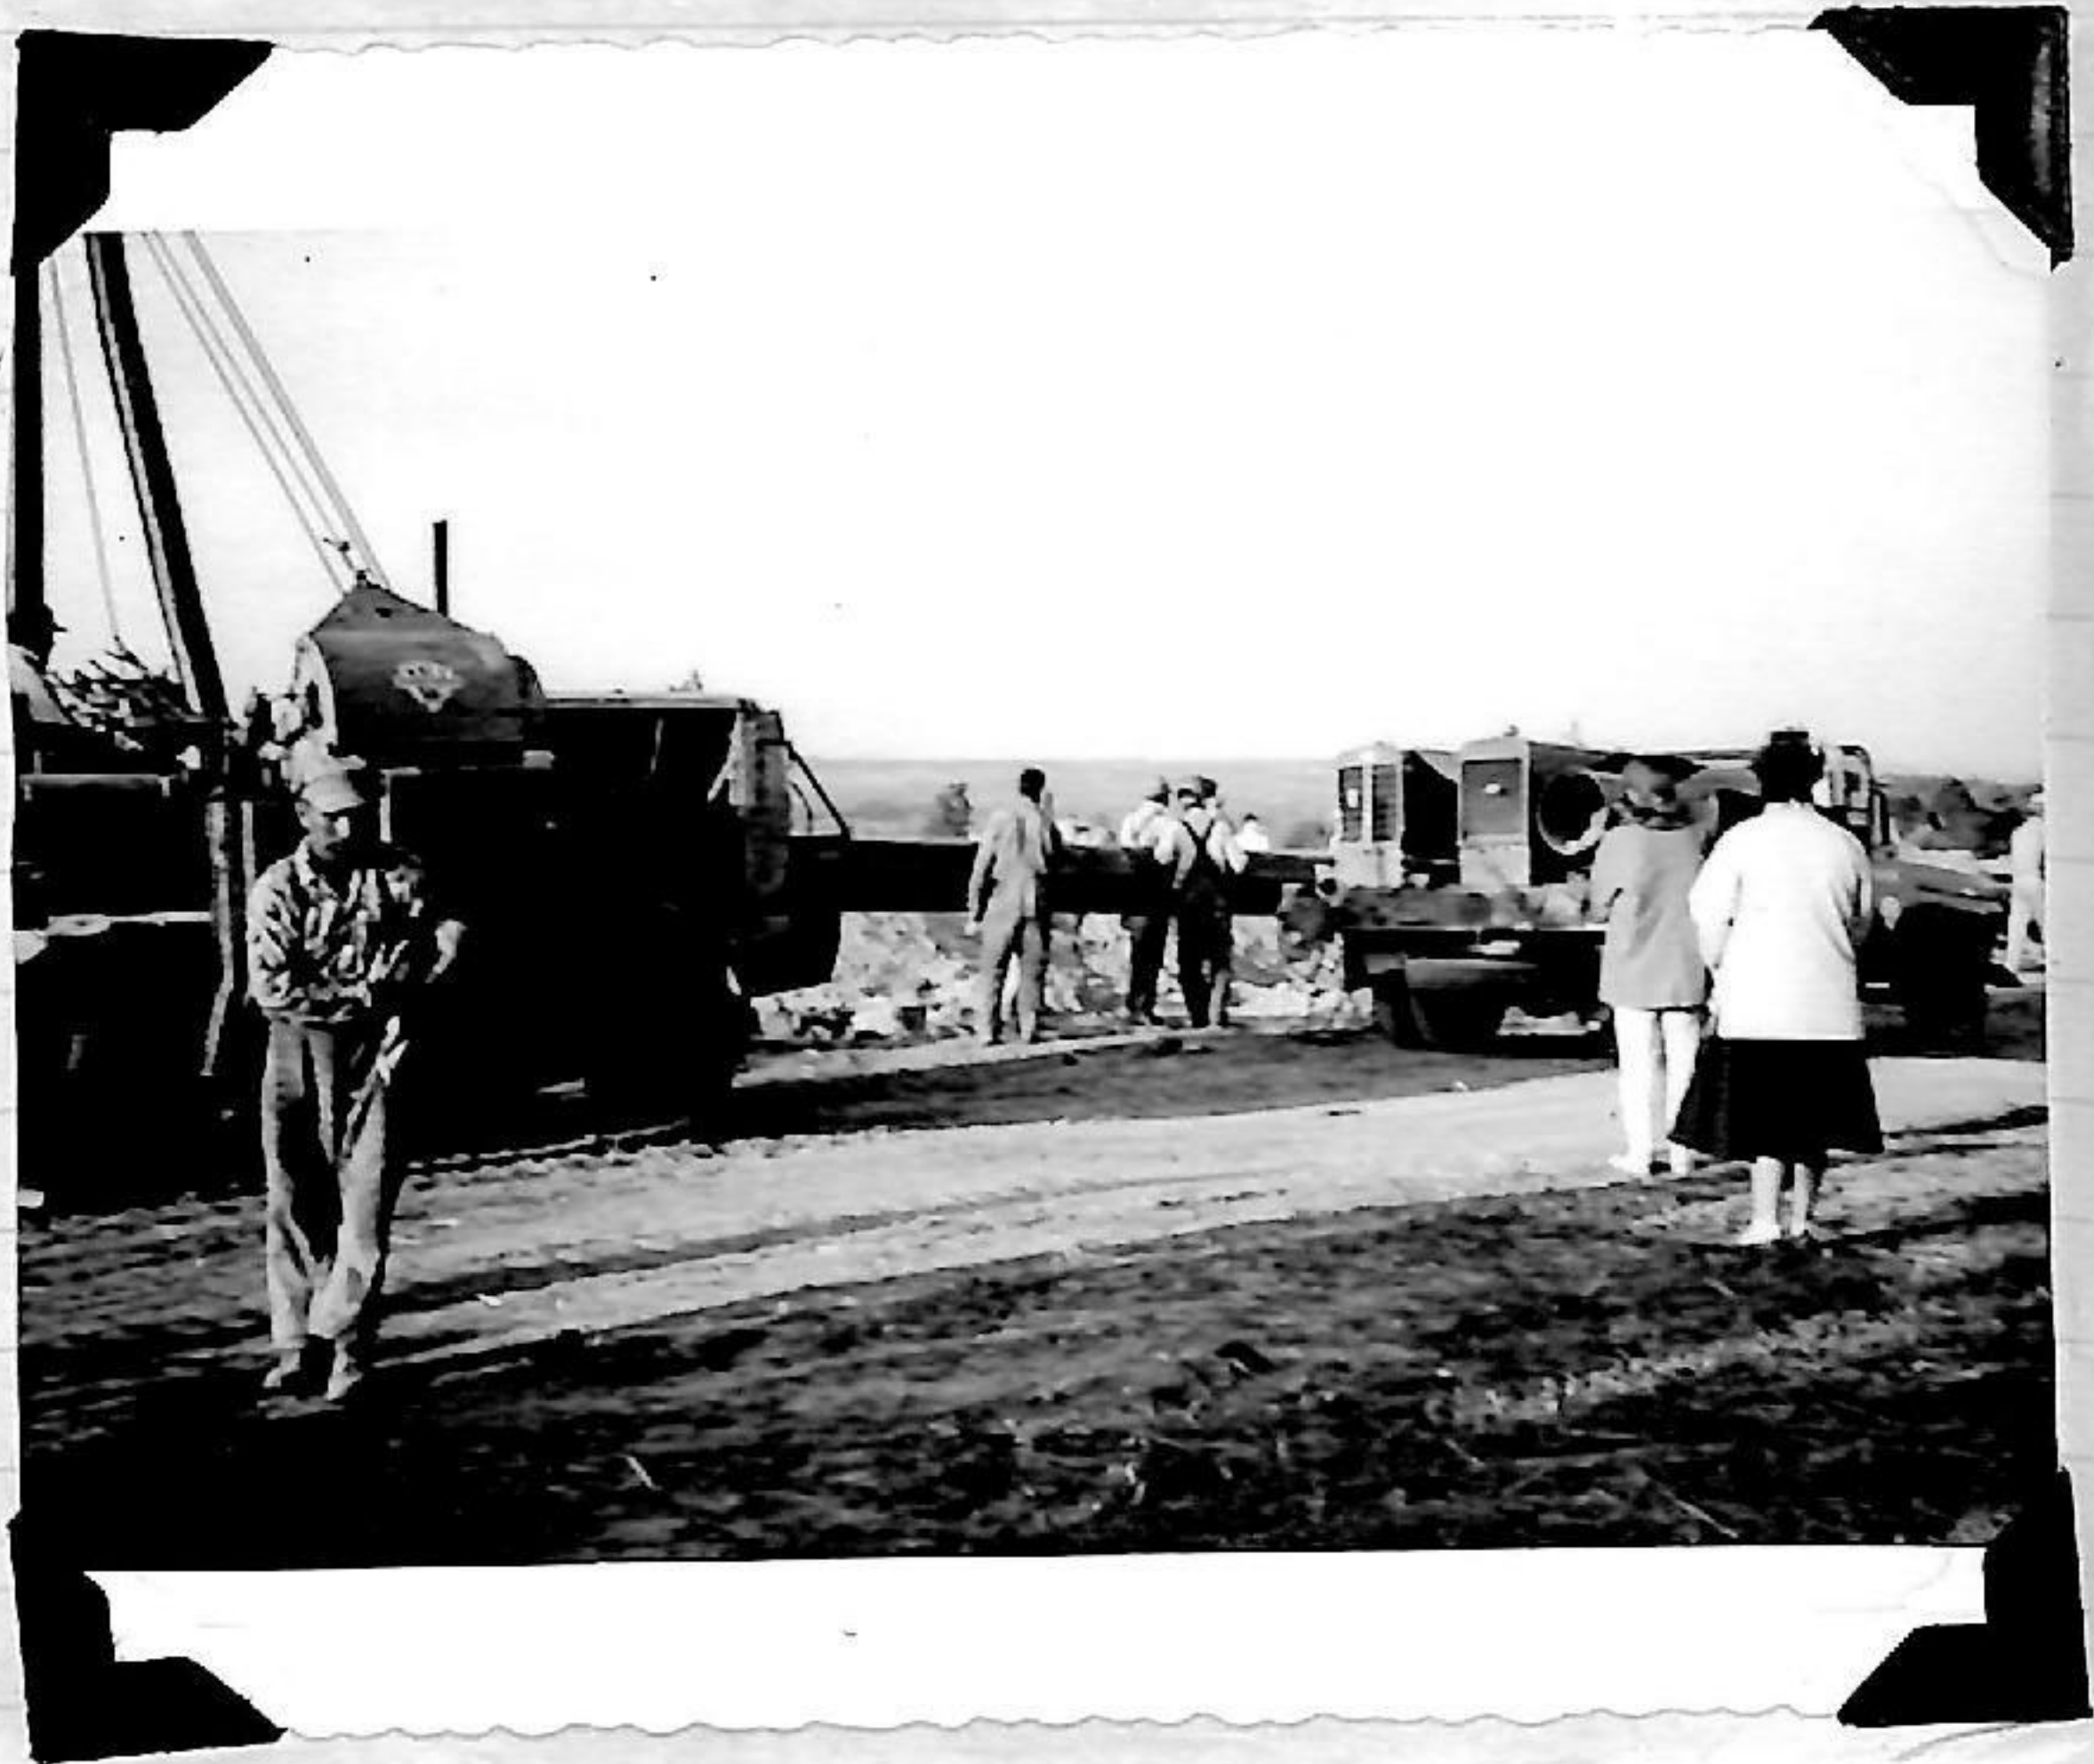
XIV

The final welding job joining together the short section of pipe used to cross the Brighton to Hooper County road to those sections already joined to go across country. The bulldozer on the left, picked up and held the short section of pipe aloft, and steady, to enable the welders to join the two sections of pipe.
