H2O horror

Incorrect softener hook-ups can lead to contaminated water

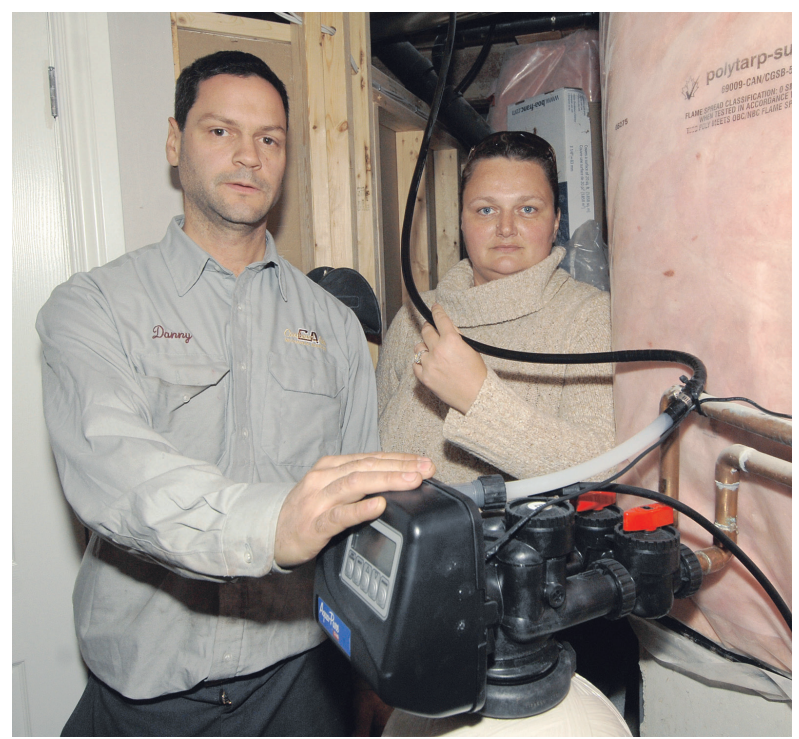
The softener's drain in the three-year-old home in Georgetown South had been directly connected to the sewage stack in the basement.

During the cycling process there is suction in the unit's drain

that could literally suck back sewer gases and maybe even sewer water into the drinking water system through the water softener.

Danny Martin of Georgetown feared the water softener in the home he recently purchased had been contaminated by sewer water or sewer gas because it was incorrectly installed. Martin, pictured above with Aneta Ludwig, Halton Region's Cross Connection Back Flow Prevention Coordinator, has replaced the softener. At right, the water softener's drain was improperly directly connected to the sewage stack in the basement.

She recommends that homeowners with softeners check to make sure they have been installed properly, and if not, contact the company that installed it to have the problem rectified.
