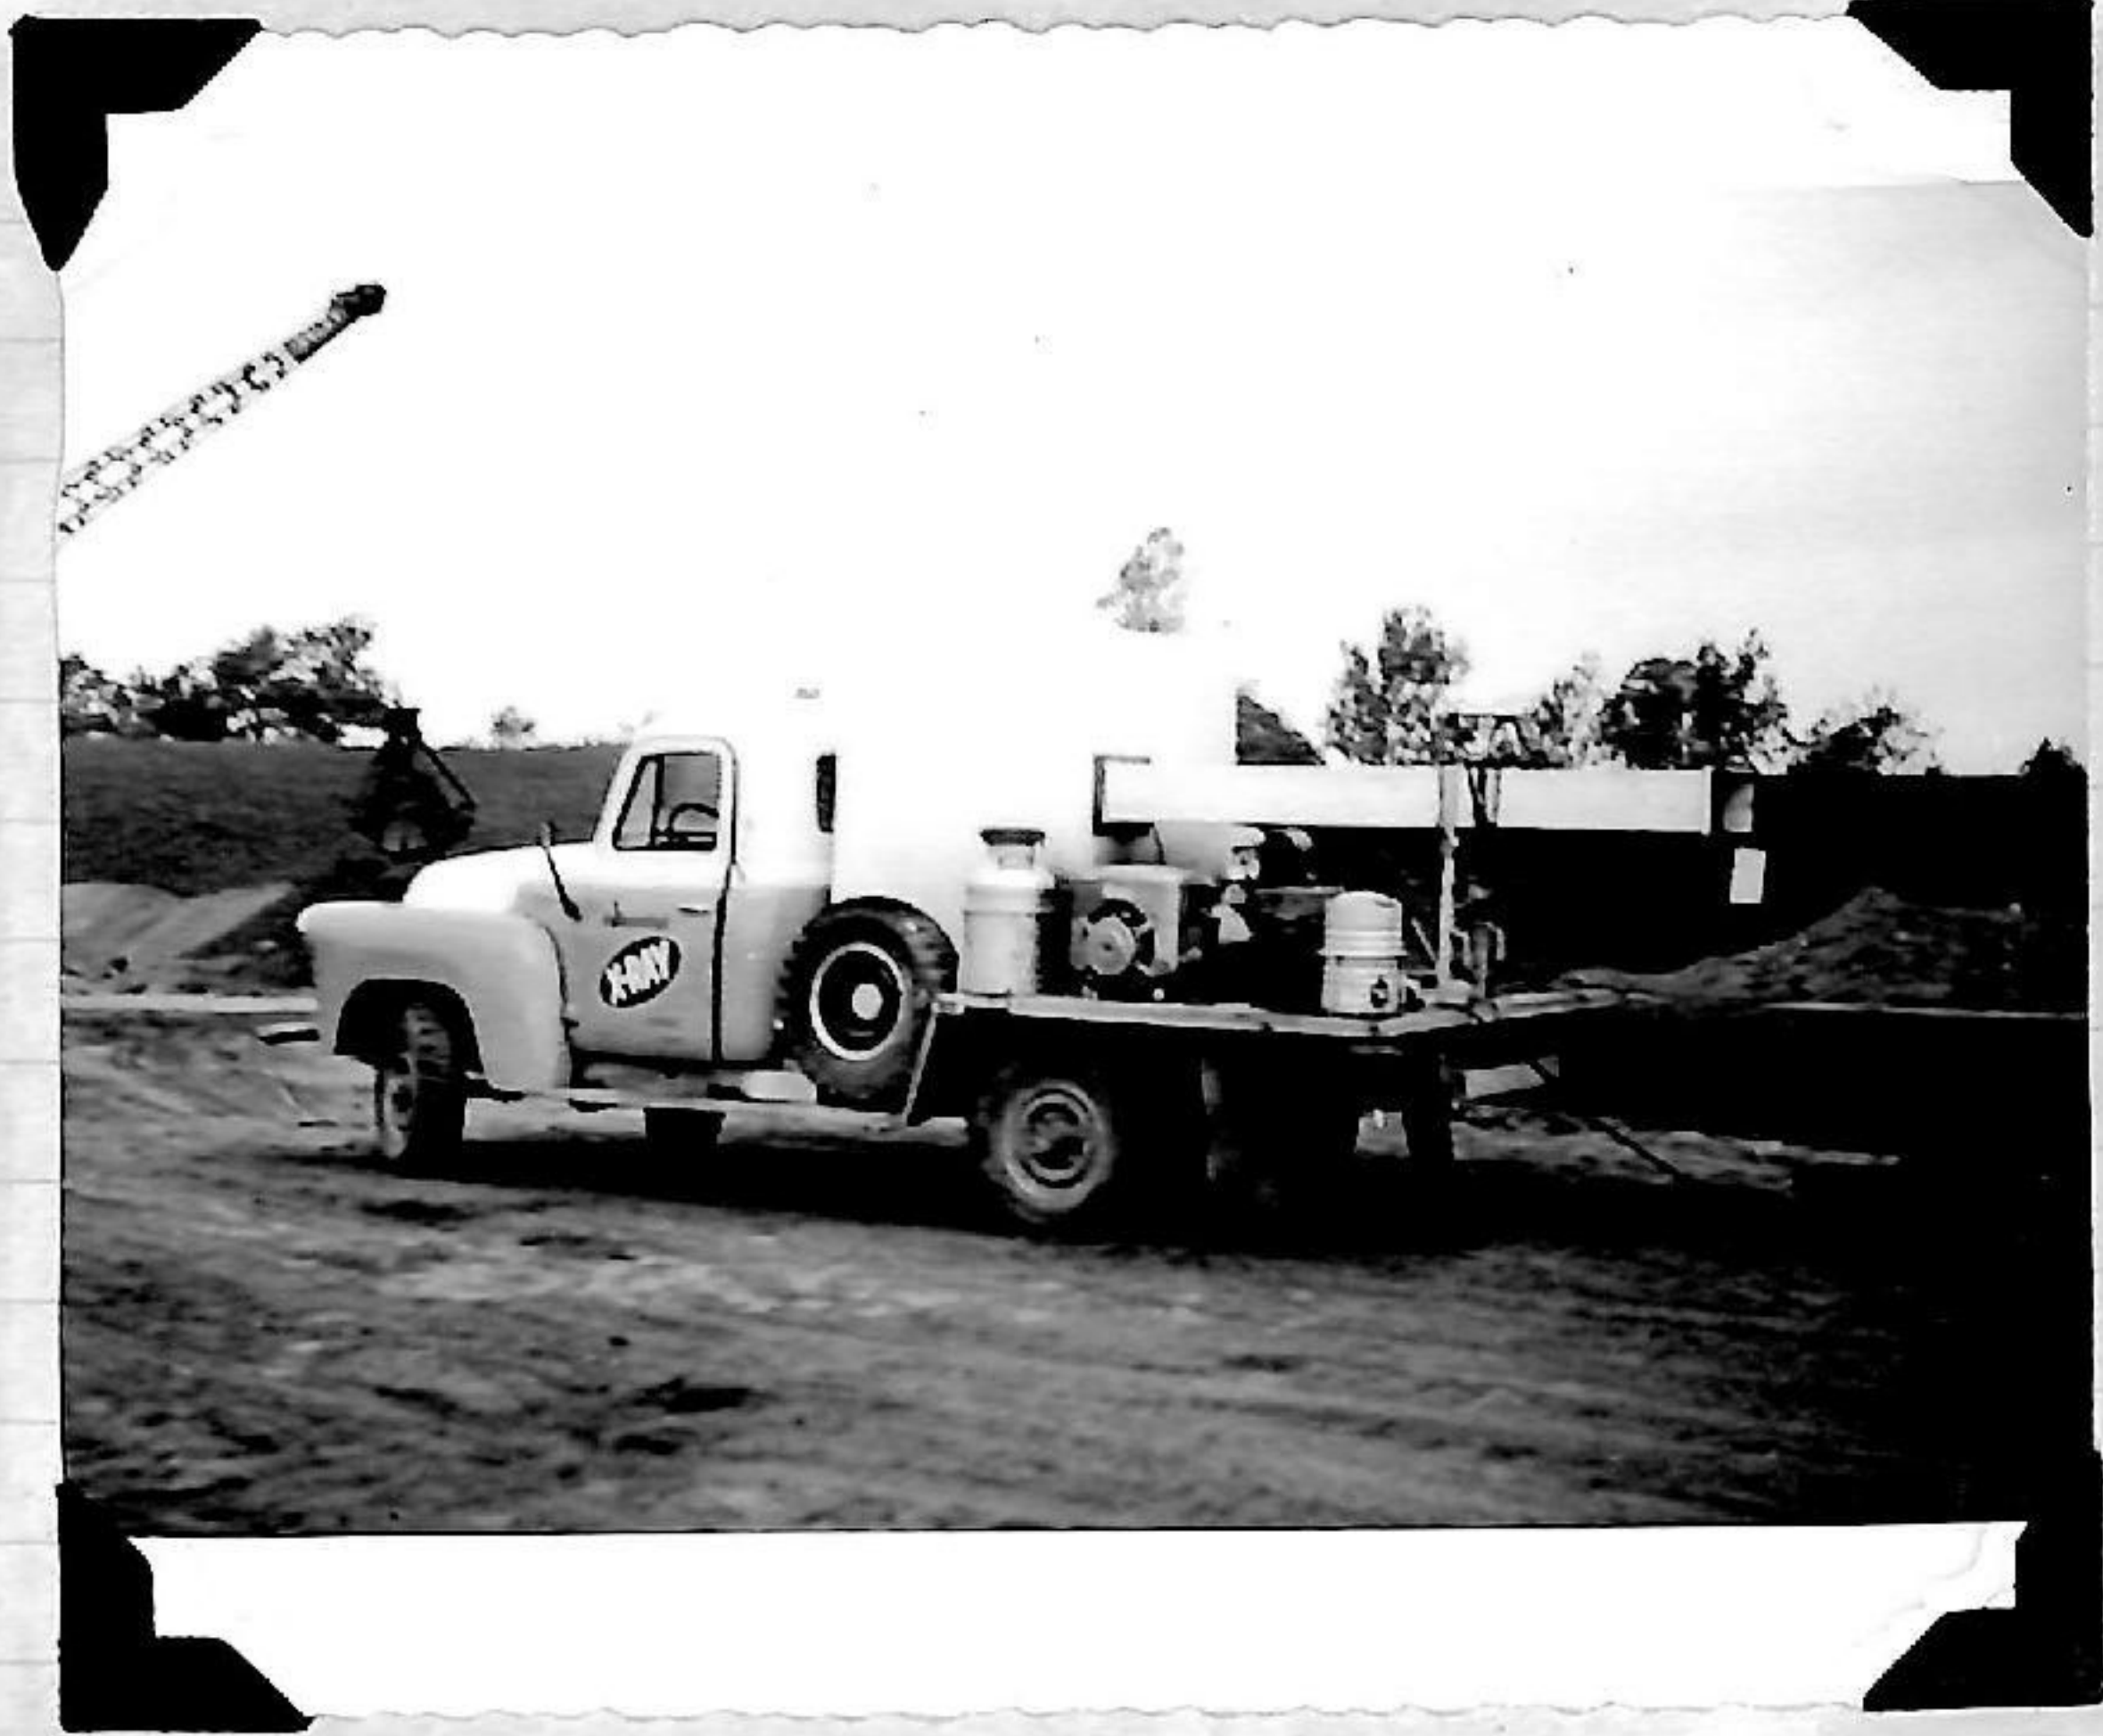
IX A close up view of a Pipeline X-Ray Truck. This machine was used to X-Ray each and every welded joint, to insure a perfect joining of each length of pipe. When this line explodes under testing pressure, it is very seldom they separate or explode at these joints, but rather a weakness in the pipe between the joints gives way and explodes.

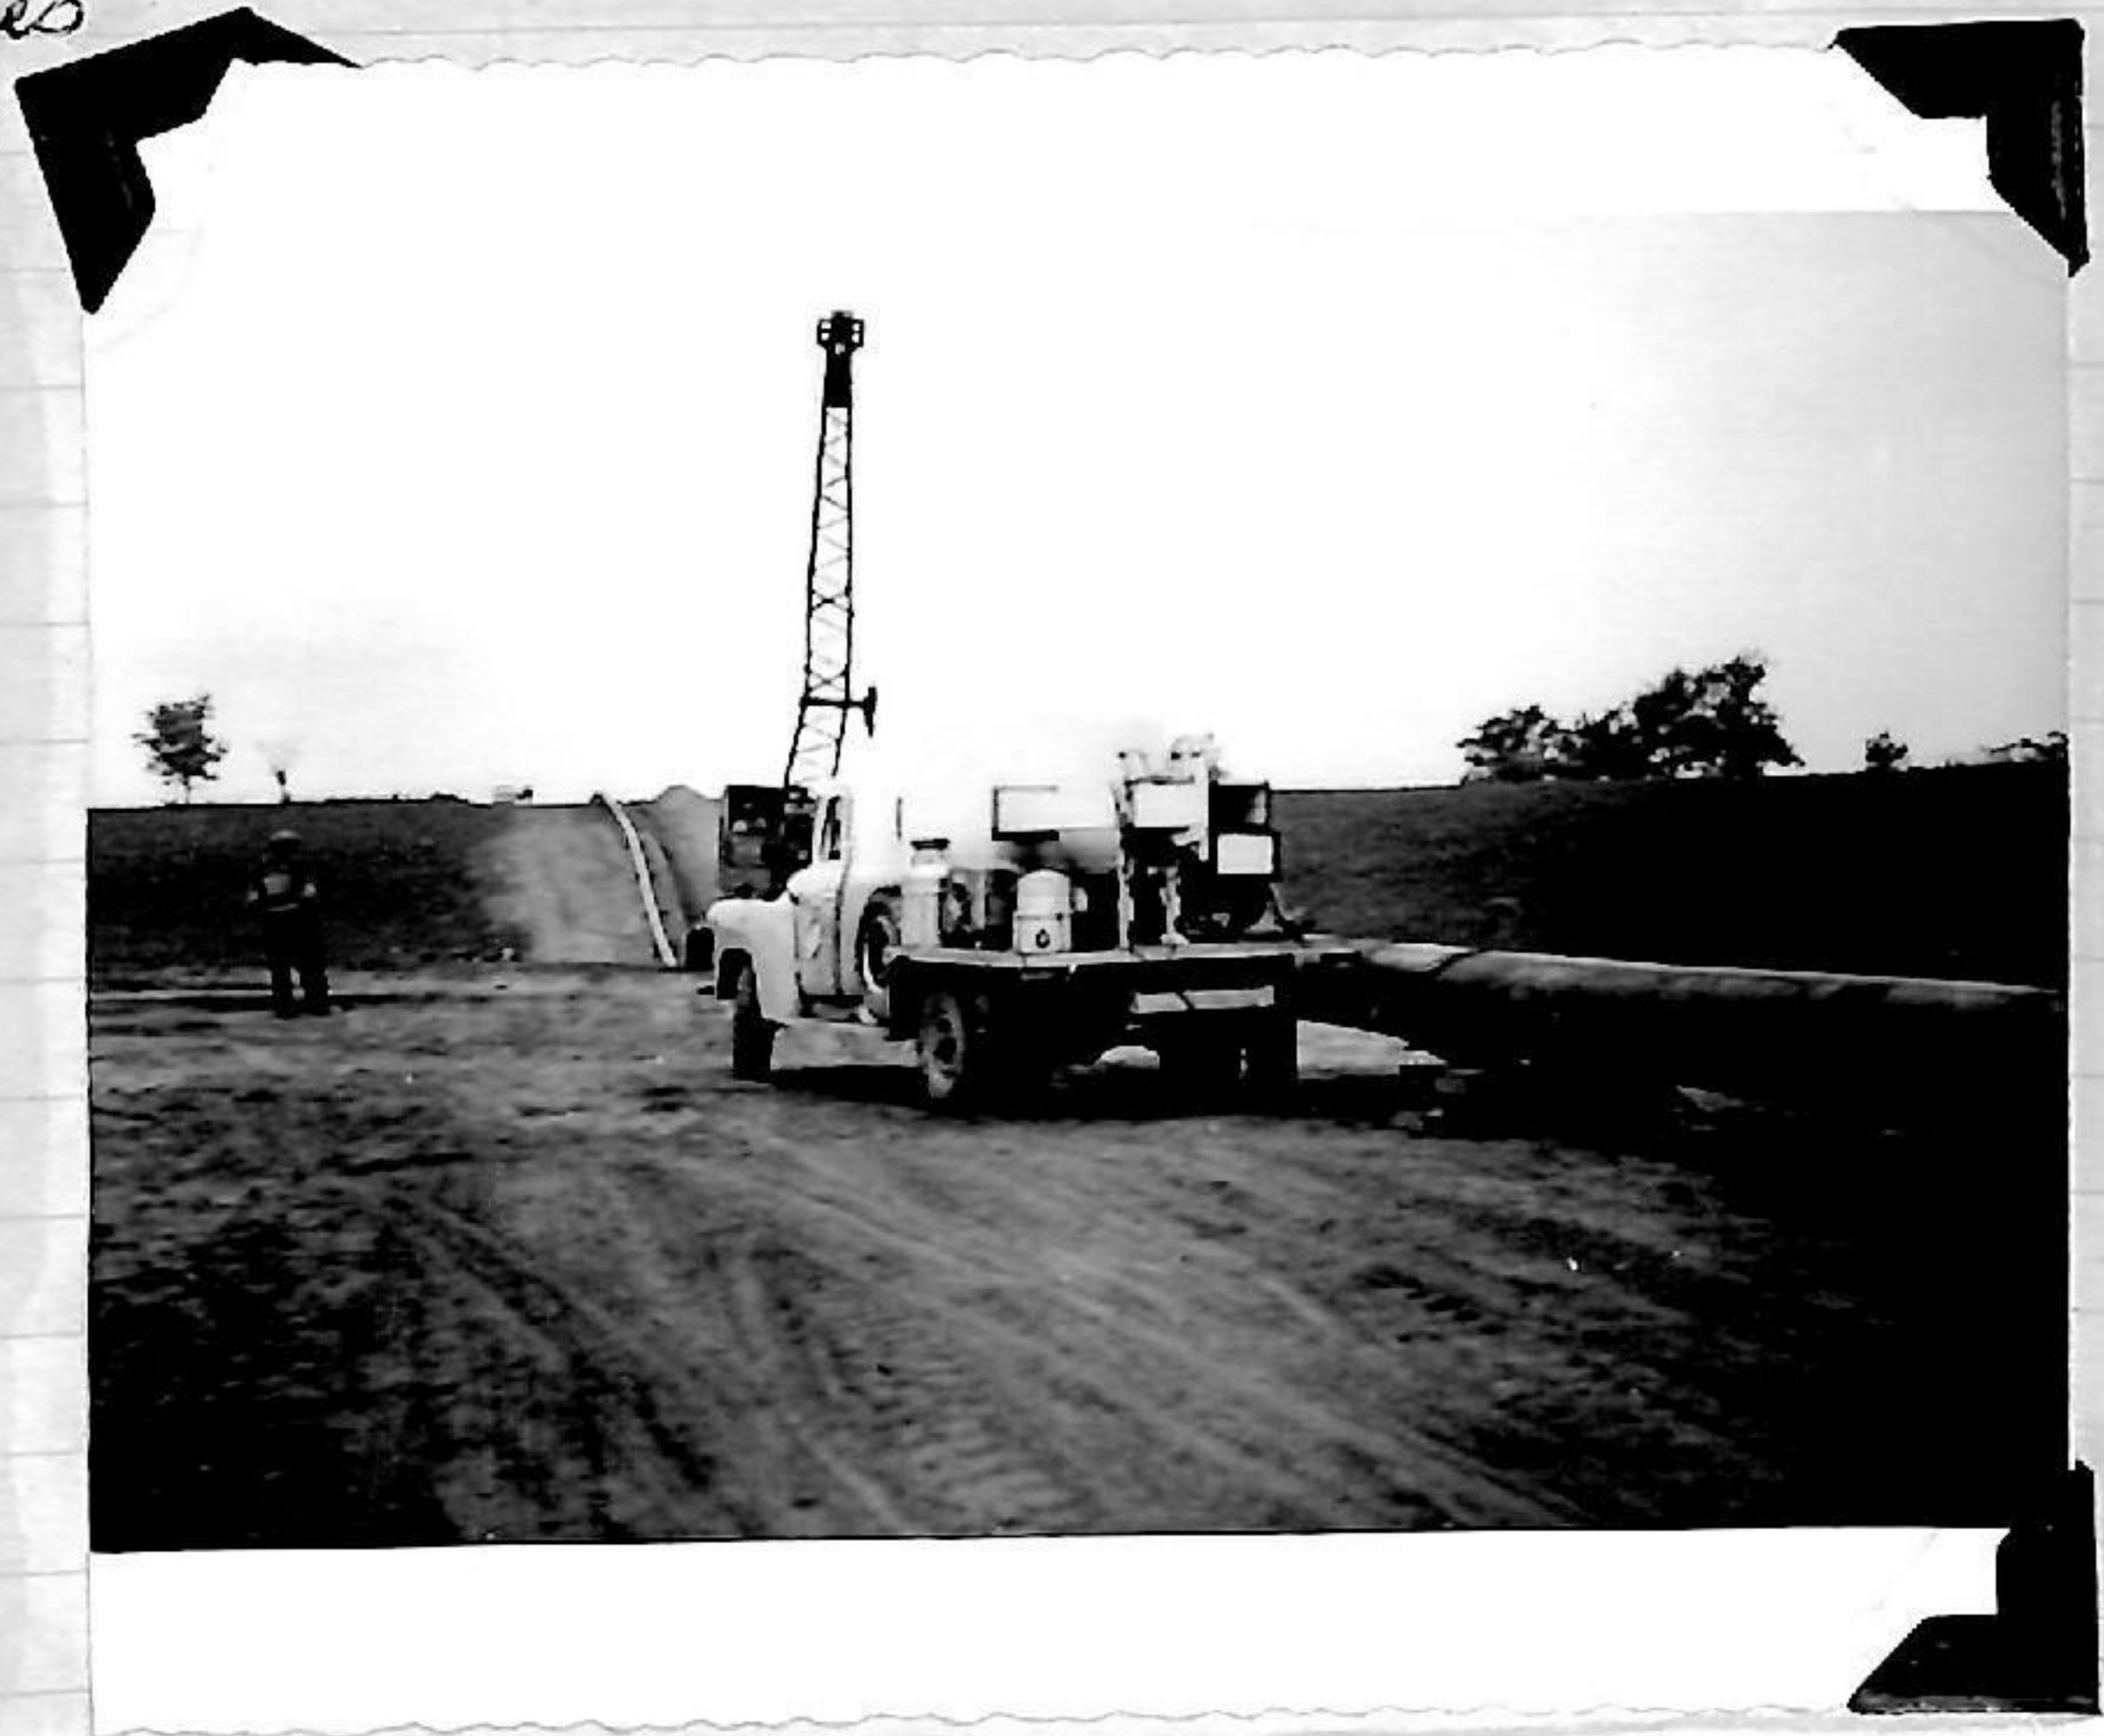
X A rear view of the same X-Ray truck. Note how the joined pipe curves up and over the hill to the west. One of many company cranes can be seen in the back-ground.
