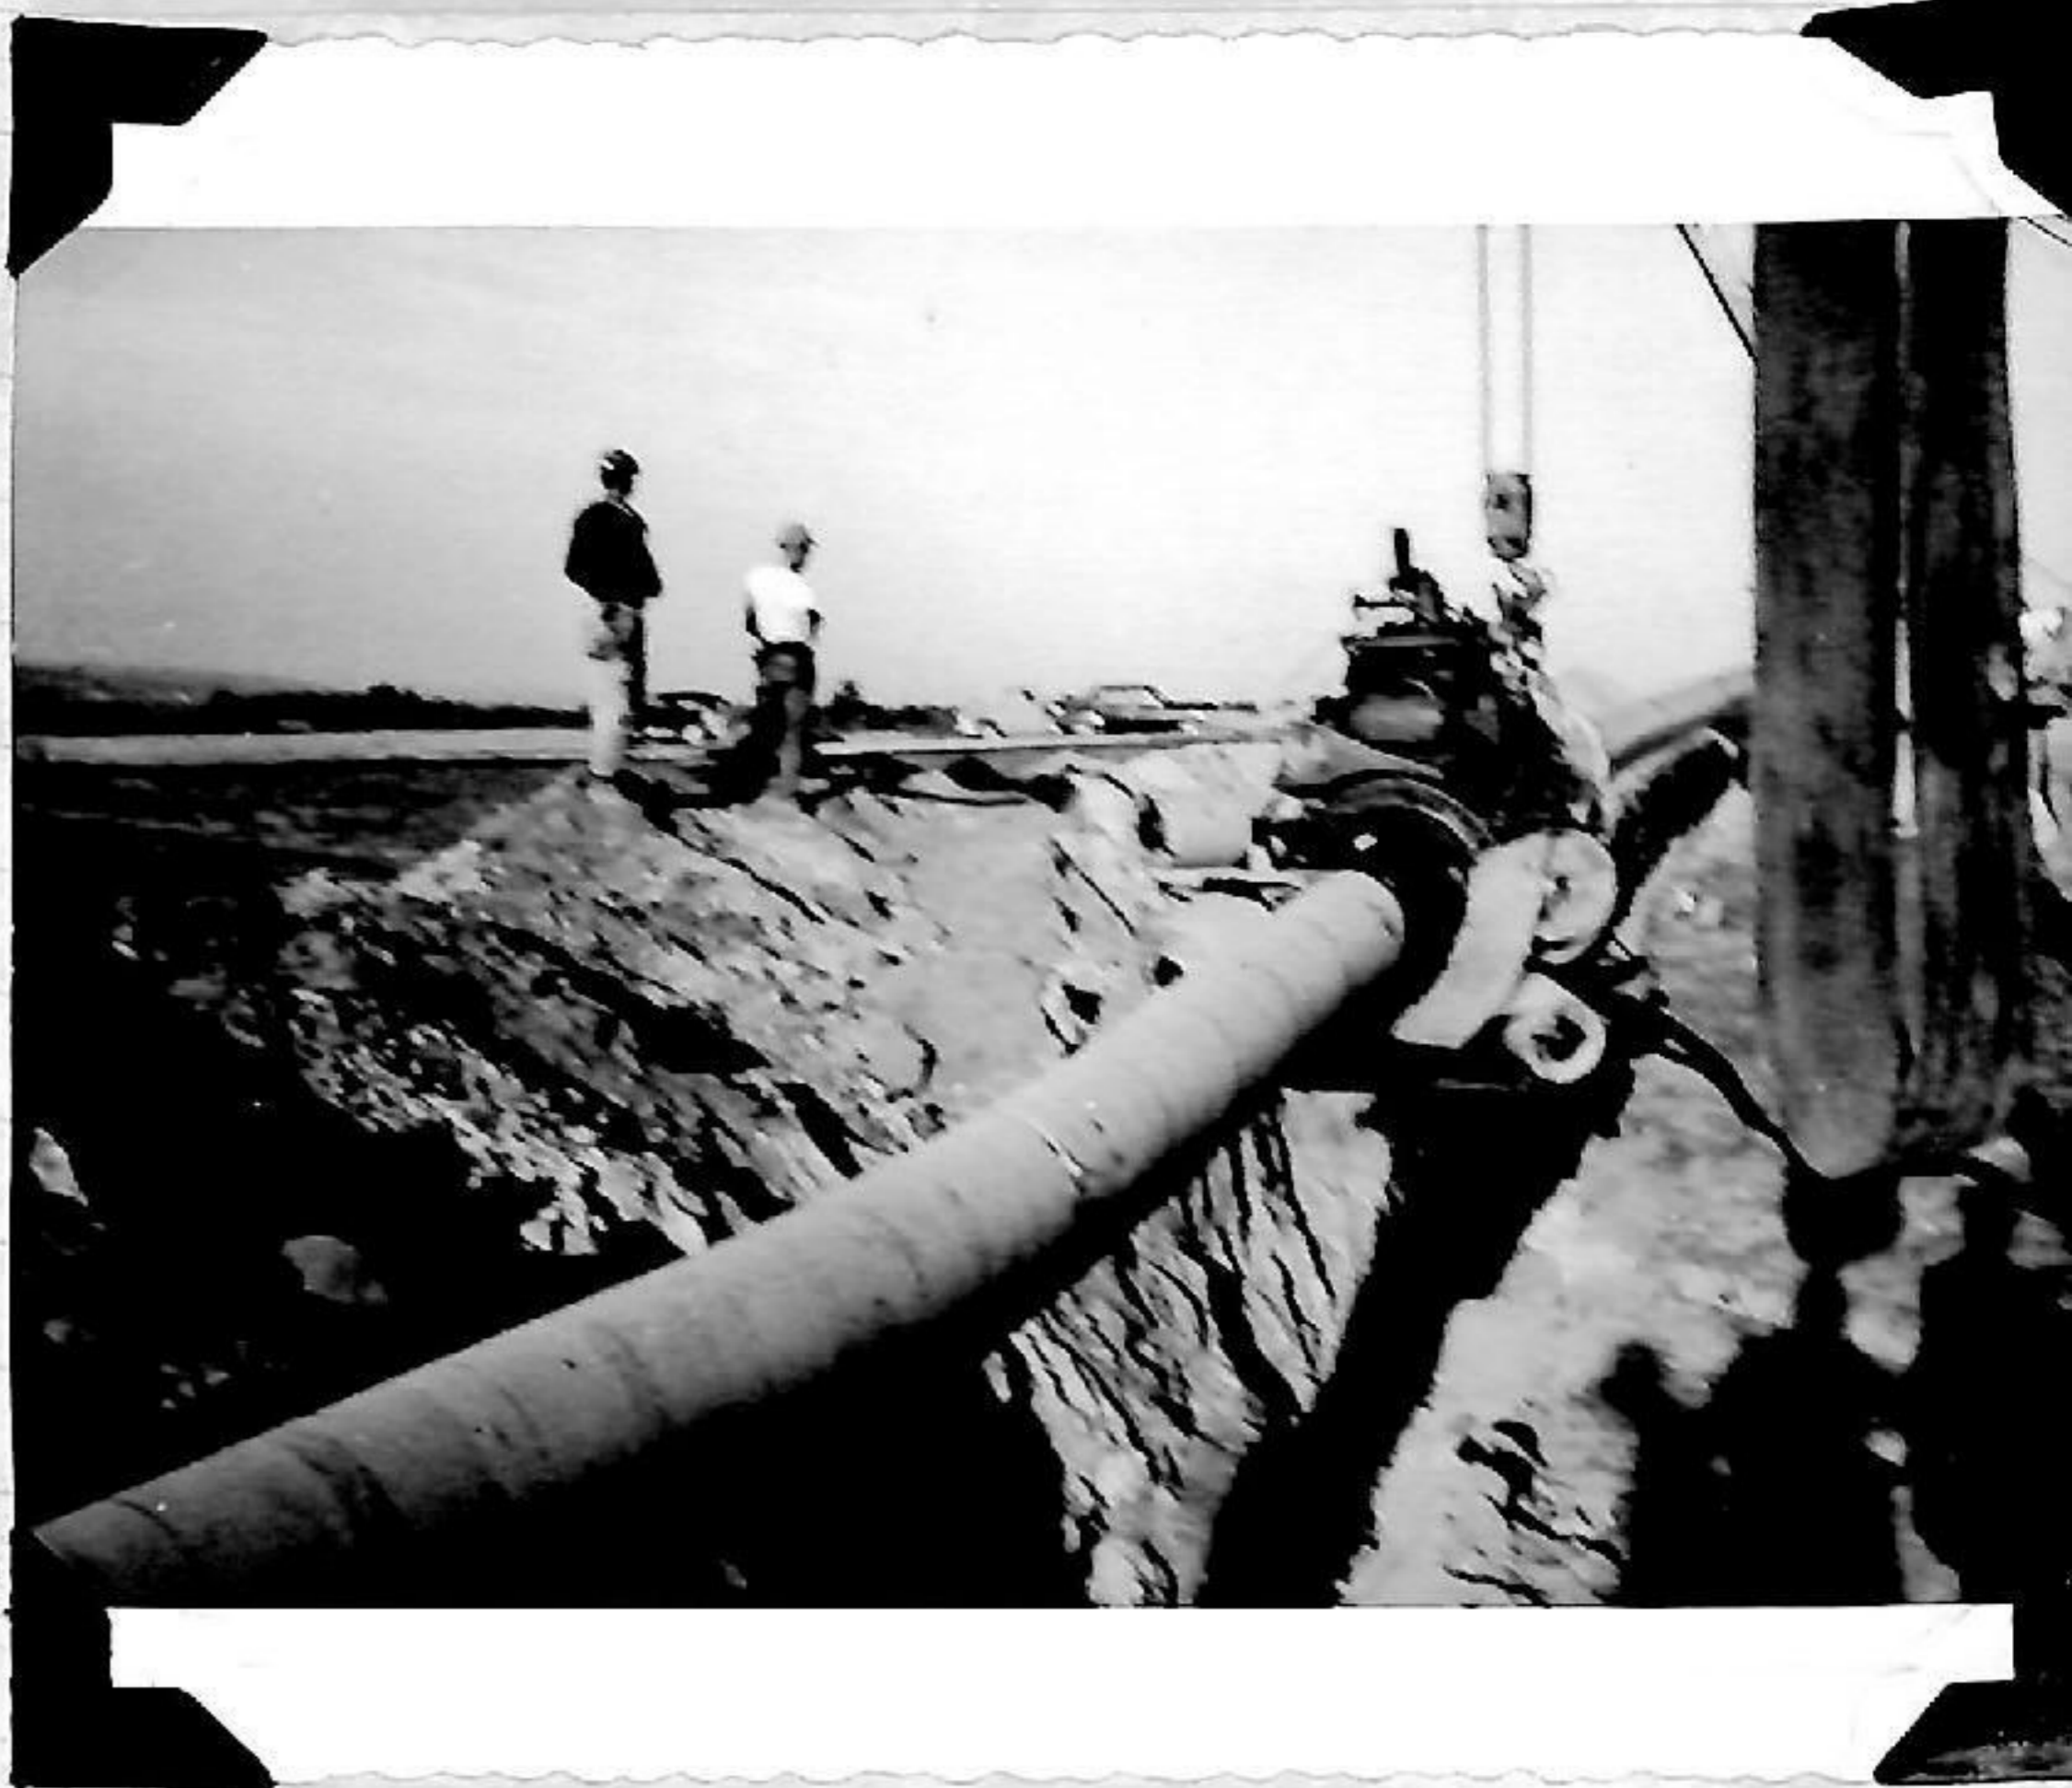
XVII A close-up view of the pipe-wrapping machine. The 4 rolls of fibreglass and hurlap can be seen quite clearly. When in operation these rolls travel counter-clockwise around the pipe and it is then laid into the ditch.

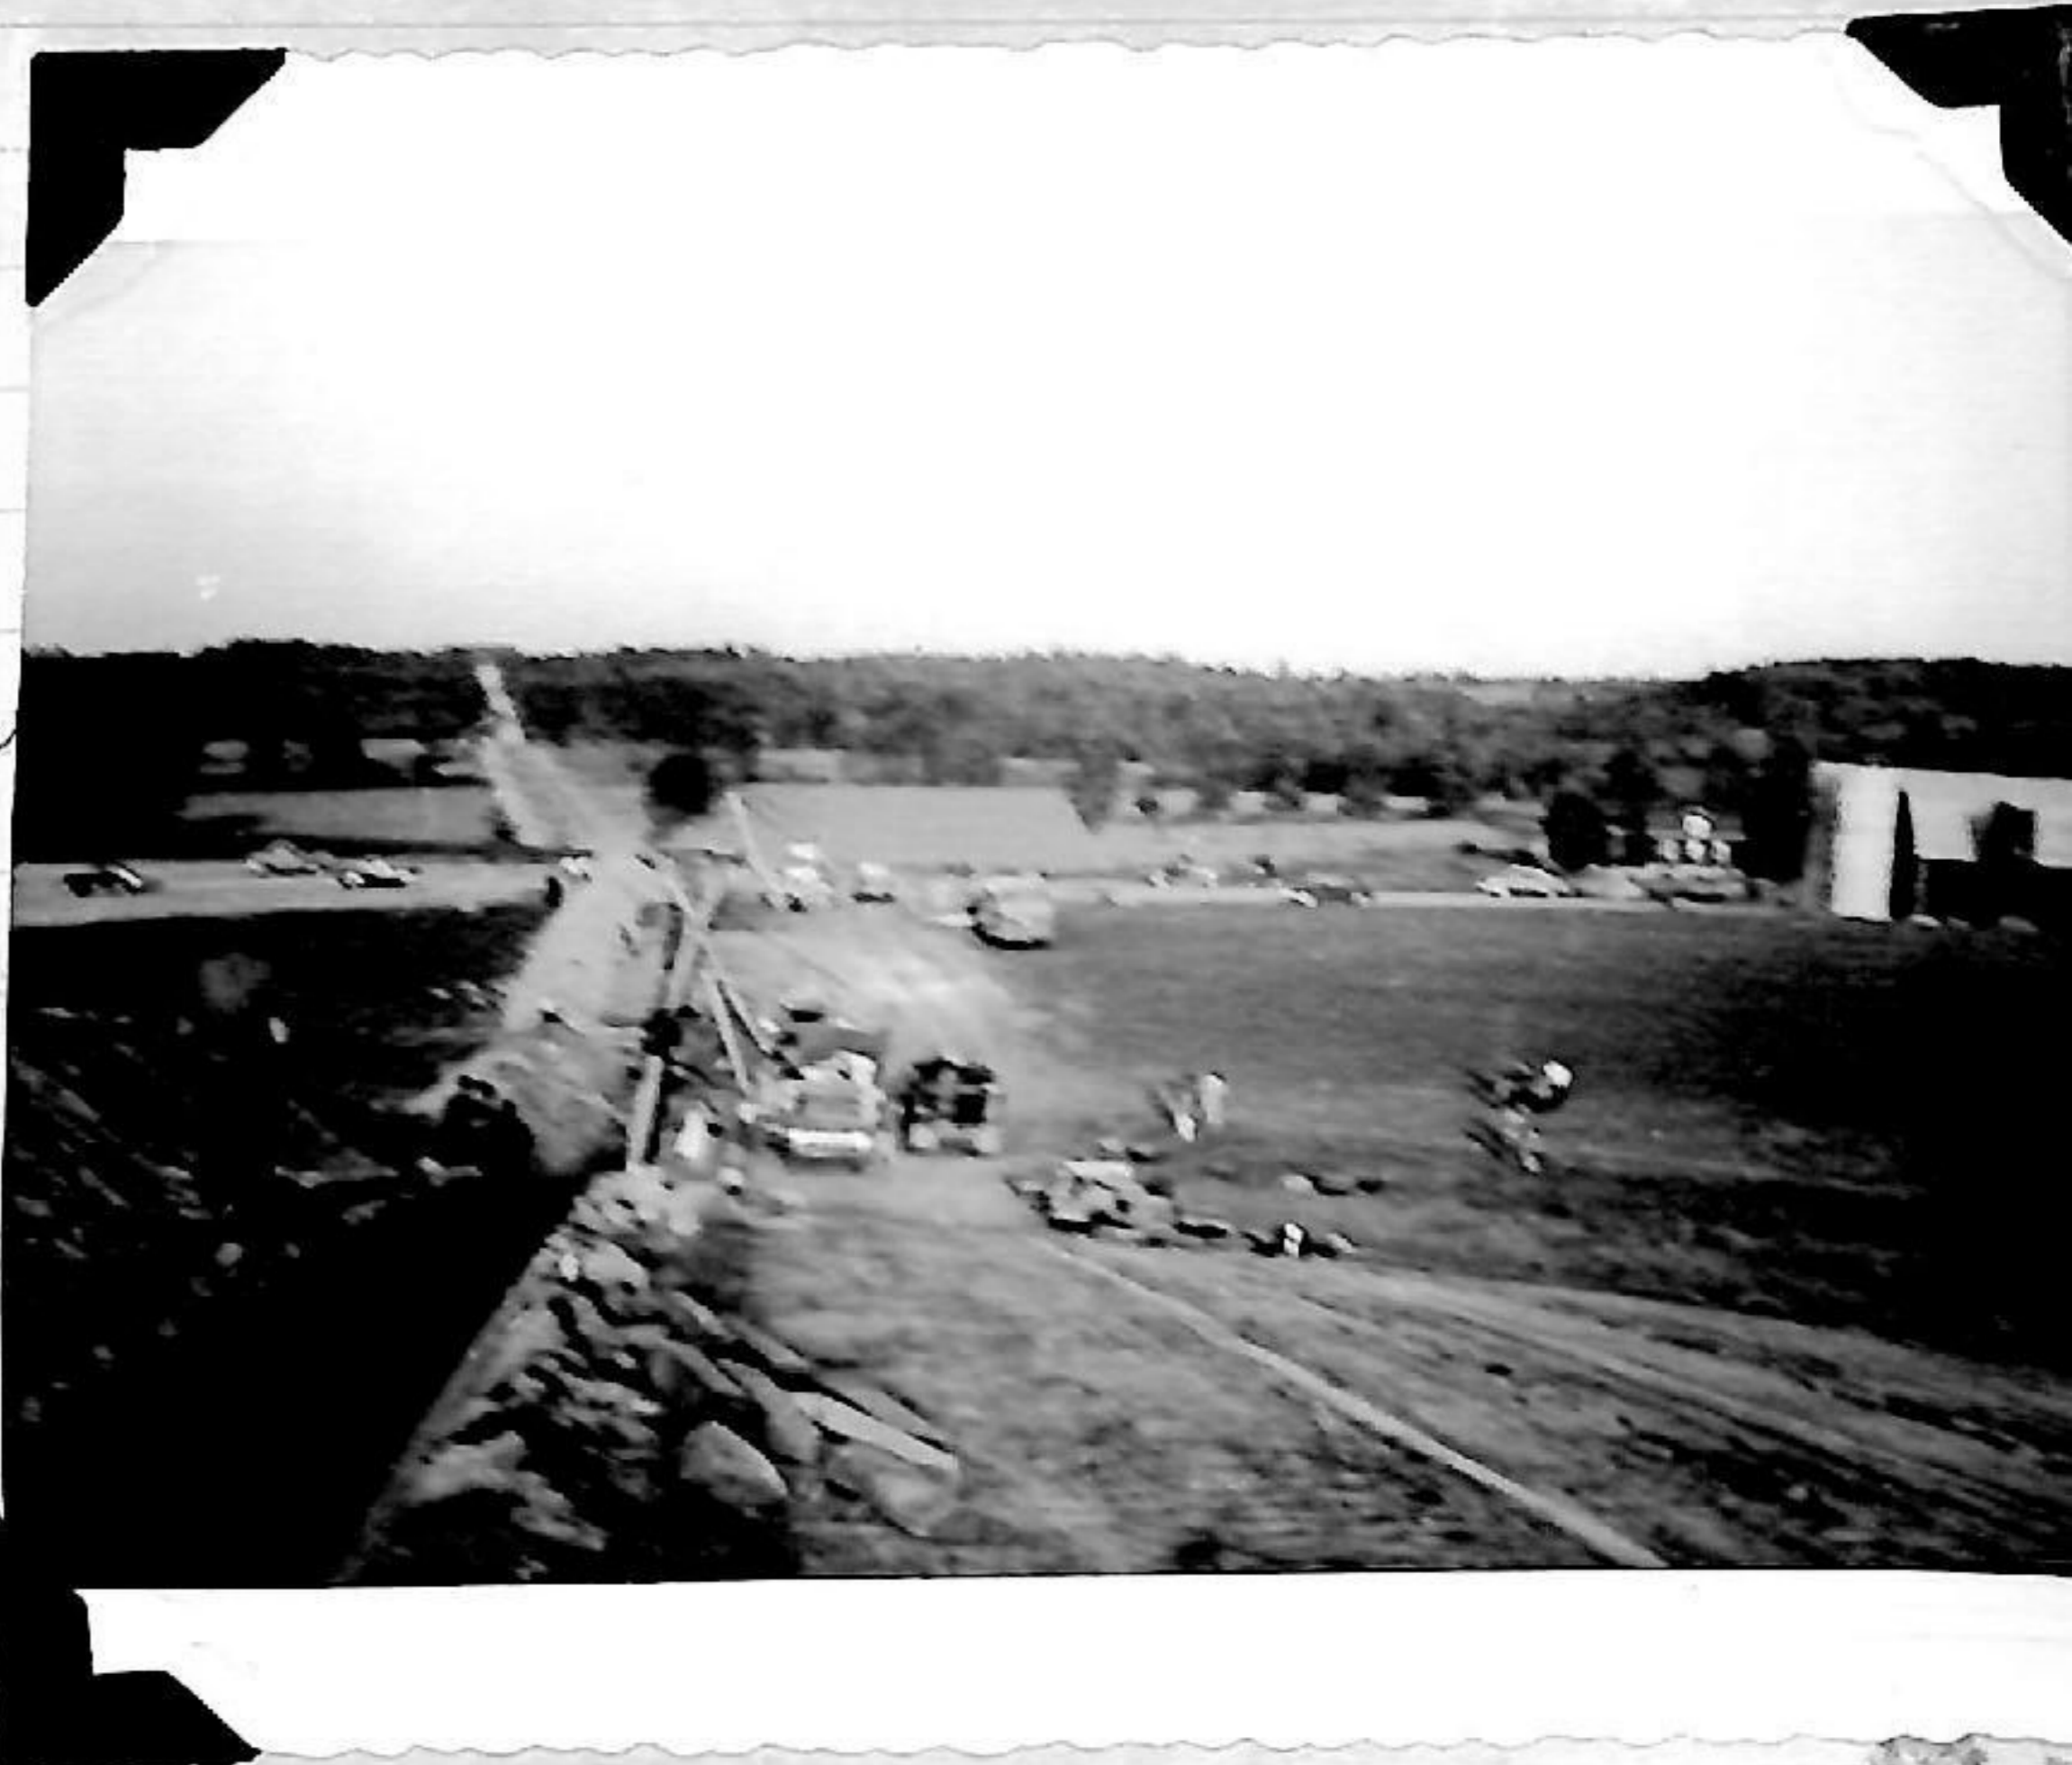
XVIII The pipe is wrapped and now is laid in the ditch, the only remaining operation is to fill in the ditch, as we took this last picture facing east, just at the western slope of the hill could be seen 2 bull-dozers pushing in the dirt to fill in the roadways for immediate use.

On that last Sunday the County Road was blocked off less than 2 hours. The rest of the ditch was filled in during the following week.
