Restoration of a log cabin in photographs

The one seen in photographs on this page has been purchased, taken down and moved. When completely finished it will be the future home of Joset Drenters, the new owner.

The interesting old building belonged to an early Canadian family named Stiffler. It was located in Pustinch township, three miles south of Guelph. Through research, Mr. Drenters learned it had been built by Pennsylvania Dutch workmen around 1838. Workmanship and construction of the building points to a continental-type carpentry.

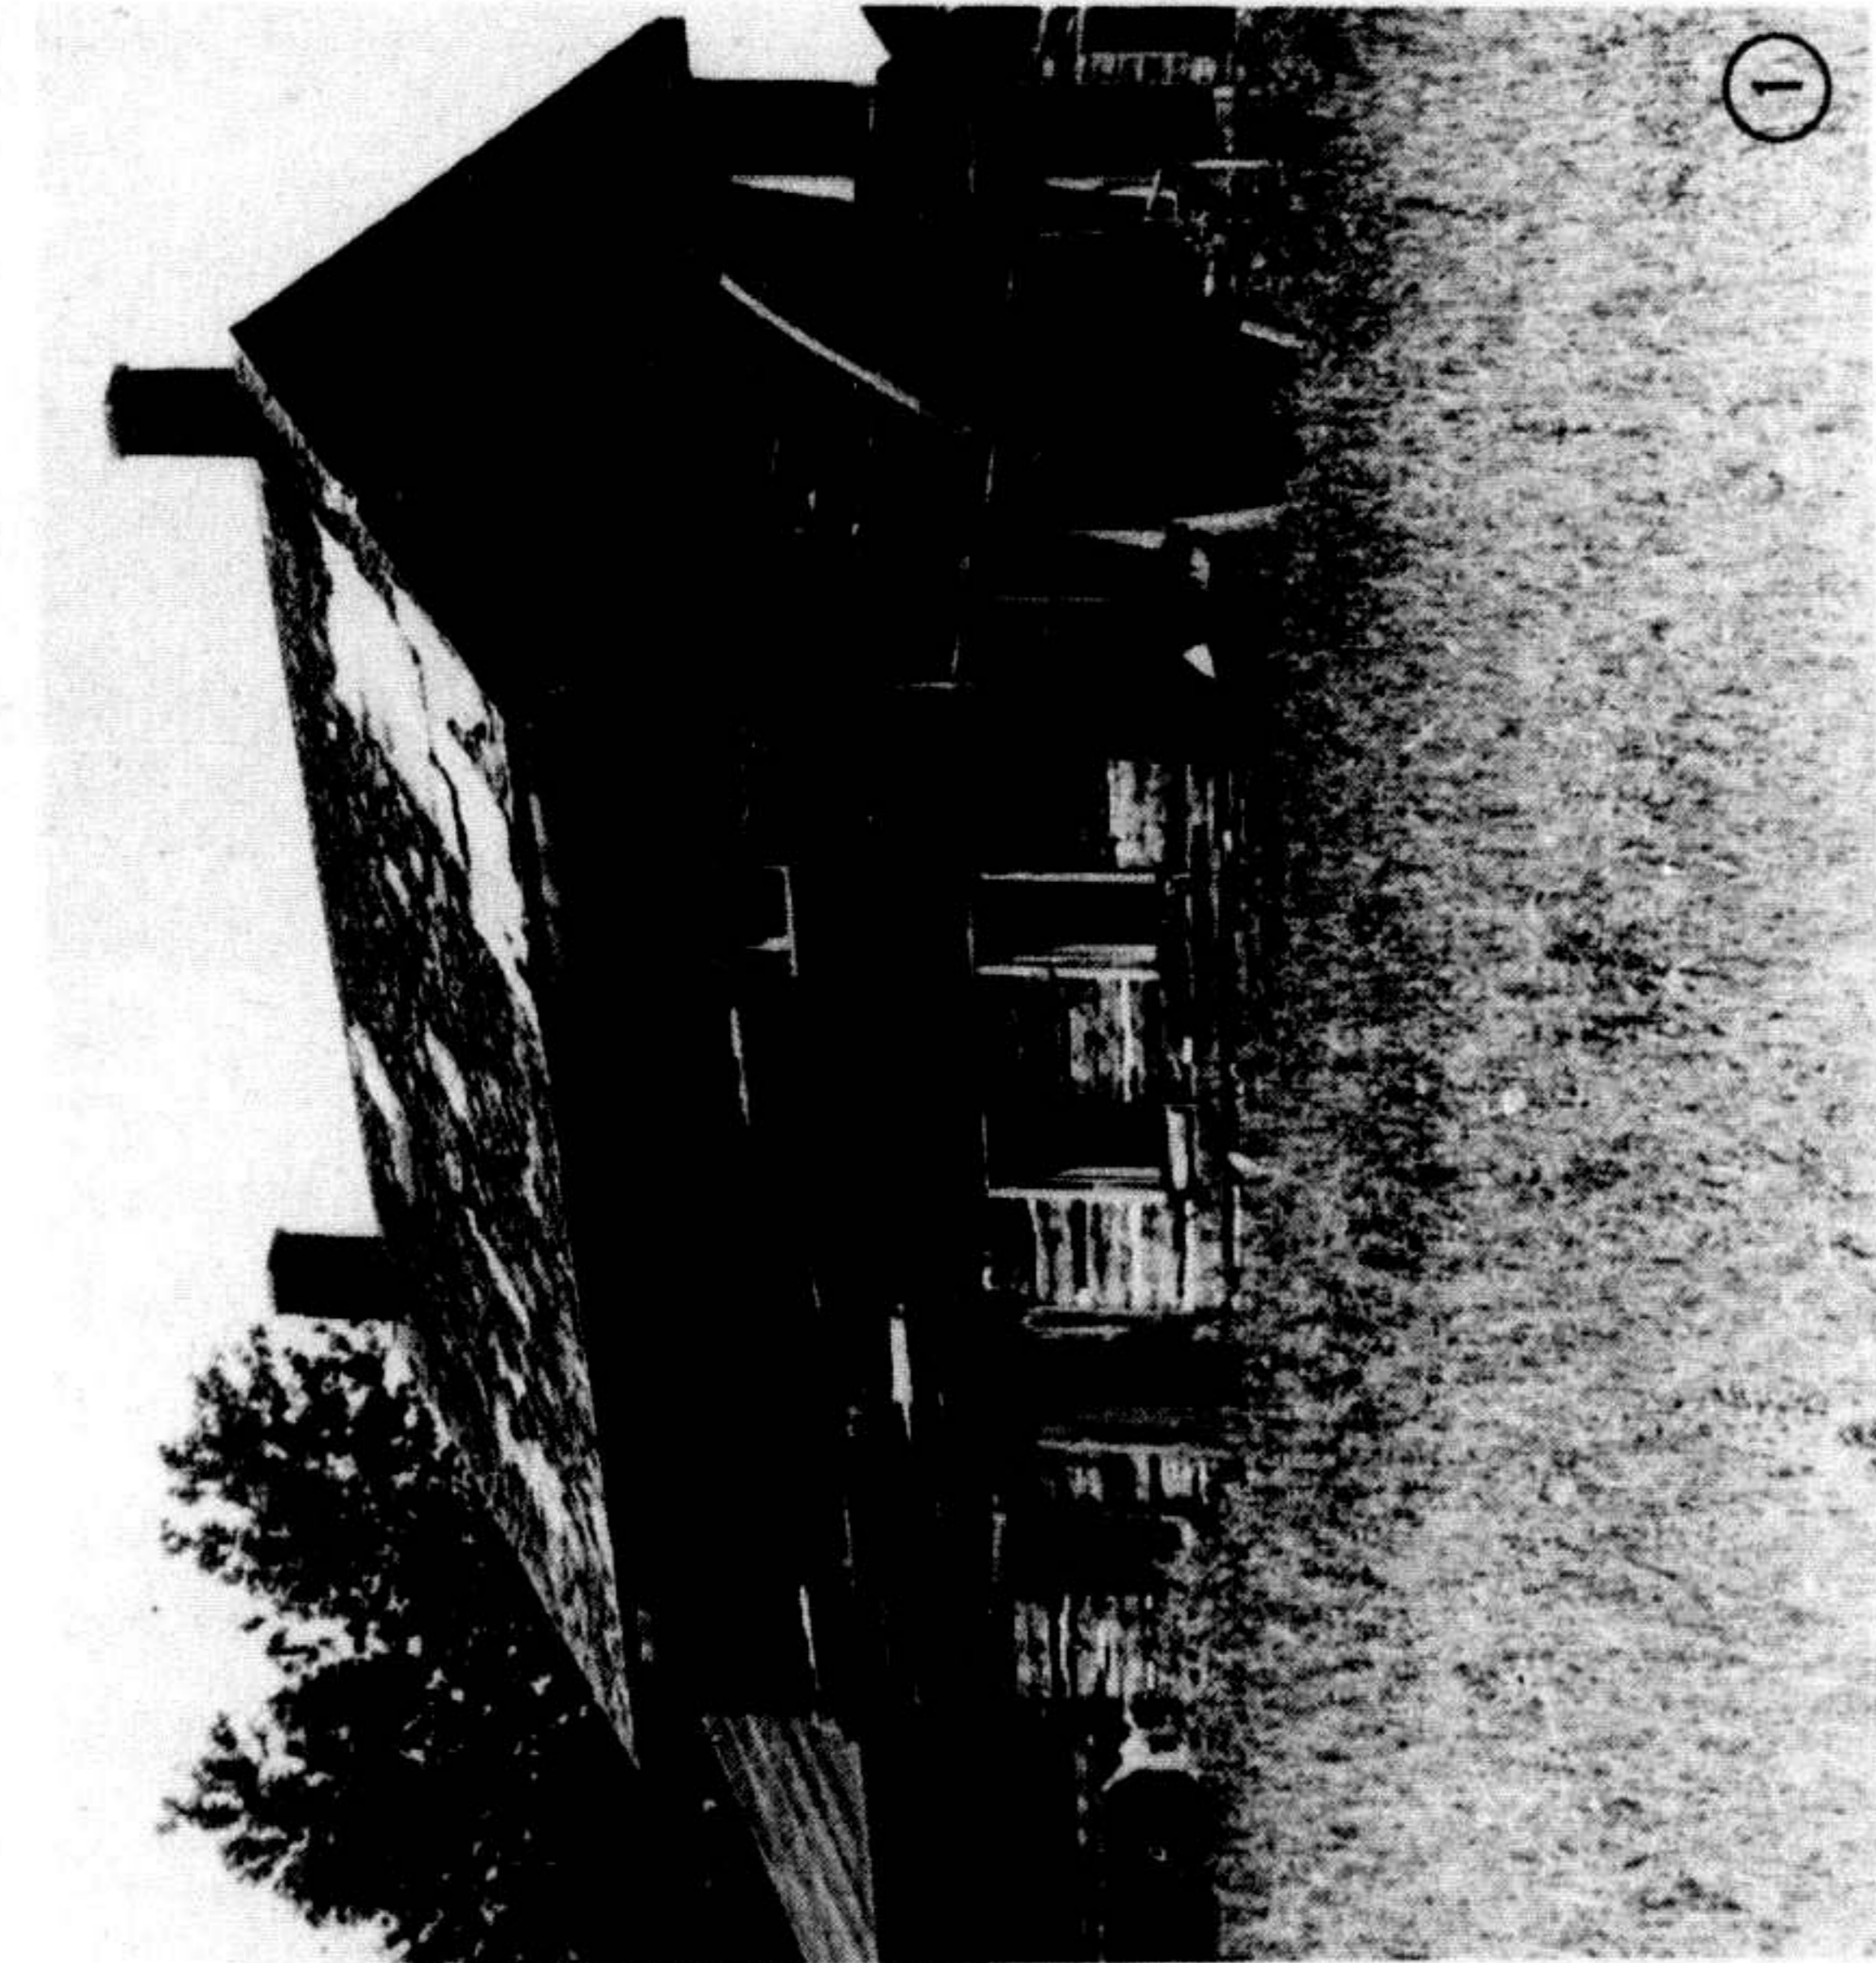
Today it stands proudly, a monument to the past, on property close beside the Rockwood Academy in the village of Rockwood. Step by step the pictures take you through the seven stages from dismantling to resurrounding. No. ① the latter building as it stood in 1973. No. ② the roof and outside clapboards were removed. No. ③ logs were numbered, taken down separately, and trucked to Academy property where they were piled neatly. No. ④ foundation was begun in spring, '73. No. ⑤ with the aid of a cant hook Joset Drenters rolls logs across to front of building over ceiling. No. ⑥ the builder is seen placing the joist. No. ⑦ the house as it stood in January 1974. All logs were raised by December of '73. In January '74 the roof was on, requiring only that glass be put in windows, doors placed and spaces between logs, chinked.
